## **Committee: Sustainable Communities Overview and Scrutiny Panel**

**Date: 08<sup>th</sup> March 2022**

### **Subject: Housing Enforcement Update**

**16 APPENDICES-CATEGORY 1 & 2 HAZARD EXAMPLES**

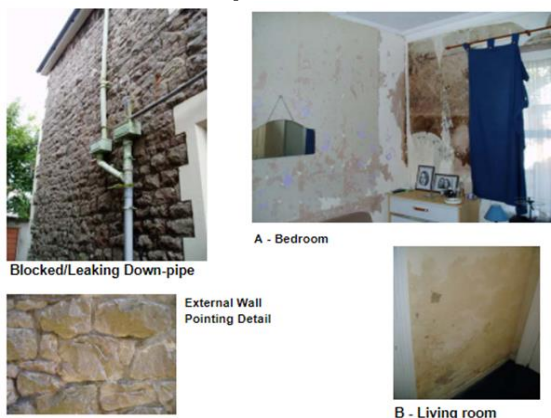
### Hazard 1 - Damp and Mould in a Pre 1920 Ground Floor Flat

A self-contained ground floor flat within a 2 storey block converted into four flats during the 1970's.

The external wall construction is of solid stone. The ground floor flat comprises of a kitchen, bathroom, living room and one bedroom.

- Bedroom: rising dampness and mould growth plus penetrative dampness due to missing pointing to the external face of the external wall and rainwater overspill due to a partially blocked rainwater down-pipe
- Living Room: rising dampness to a height of 1000mm above finished floor level due to a lack of an effective damp proof course to the walls. All walls of the room show dampness (significantly damp to the touch) with salted and perished wall plaster and mould growth present.
- Kitchen: rising dampness evident to the external walls due to the lack of a damp proof course and missing external pointing. Mould growth present

**Justification:** The presence of severe dampness in most areas of the flat means there is a high likelihood of harm occurring in the next twelve months. There is constant dampness and also mould in the main rooms, which will have a psychological effect on the occupants

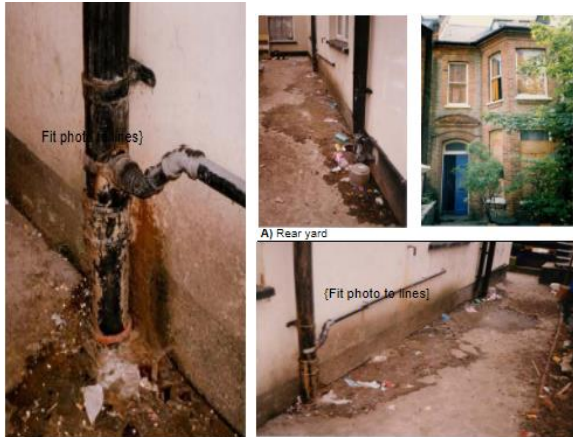
## Hazard 17 Personal Hygiene (sanitation and drainage)-The house converted into flats

The four completed flats are self-contained, each with a combined bathroom and wc and separate kitchen. Soil pipe: The soil and vent pipe serving the first floor back addition bathroom is leaking at the joint between the pipe and the waste pipe from the ground floor back addition bathroom. In addition, the drain, which runs directly to the main sewer, appears to be partially blocked causing foul and wastewater to back-up and leak out onto the common rear yard.

**Justification:** There have been recent works to the house, including alterations and additions to the drainage system, the main drains are still suitable to a pre-1919 dwelling occupied by a single family. Although the first floor flats are less likely to be affected than the ground floor flats, the discharging of foul water on to the common yard means there is a very high likelihood of an occurrence within the next twelve months

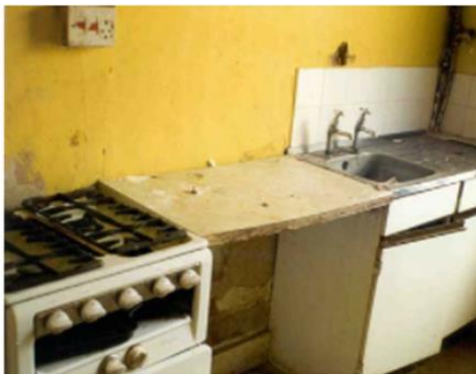
## Hazard 16 – Food Safety - Pre 1920, Semi-Detached House

Narrow kitchen: The small kitchen is 2.5 m long by 1.5 m wide. Arranged at one end of one of the longer walls is a 1000 x 500 mm, single drainer sink above a sink unit, with a drawer and cupboards below, and a 500 x 500 mm free standing gas cooker at the other end

A crudely cut and bowed 750 x 500 mm sheet of strawboard spanning between the sink and cooker provides a worktop. Other than the cupboards and drawer under the sink, there are no provisions for the storage of food or kitchen equipment. Provision for a small refrigerator under the worktop is given by the single socket in the wall above the edge of the cooker, but this is the one and only electrical power outlet in the

kitchen. This would also put the refrigerator close to the existing, poorly insulated cooker.

**Justification:** The unstable worktop is not sufficient to accommodate the normal range of kitchen equipment and ensure the separation of cooked and uncooked foods and its porous surface and poor clean ability. With only one socket available the chances of any refrigerator being accidentally left disconnected is also increased. Overall, the risk of food poisoning over the next twelve months is extremely likely.

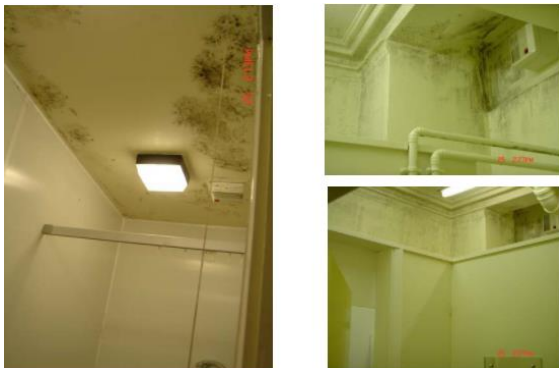
#### **Hazard 1 - Damp and Mould- First Floor Rear Bedsit In House Constructed In 1949**

This is a three storey detached house. There are four bedsits, a large shared kitchen and shared bathroom to the ground floor, three bedsits and shared bathroom on the first floor, and two bedsits on the second floor. There are wash hand basins in each bedsit. The shared bathrooms lack space-heating provision, are internal and rely on artificial lighting and mechanical extraction. Ground floor bathroom contains 2 showers, 2 baths, and a single WC. There is also a separate WC to the ground floor. The first floor bathroom contains a shower, a WC, and wash hand basin. The extractors to both bathrooms are inoperable, and both are affected by severe mould growth

NB-The dwelling being assessed is the first floor rear bedsit.

**Justification-** Although there is no evidence that there is dampness and mould in other locations, the presence of mould in both bathrooms means that occupiers of this bedsit will be exposed to mould spores over a twelve-month period. Even though this may be for relatively short periods, this exposure will increase the risk of causing or exacerbating asthma or other respiratory conditions.

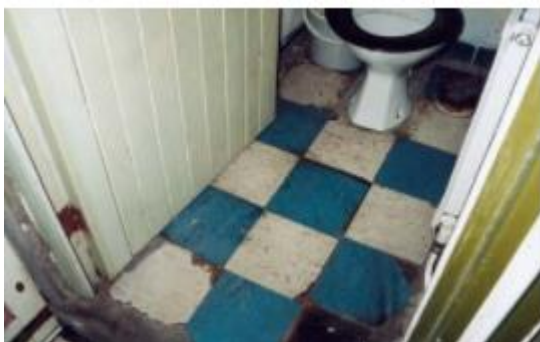
#### **Hazard 17 Personal Hygiene (sanitation and drainage)- 3 bedroomed mid terrace house**

3-bedroomed early Victorian house modernised in the 1970s when the original external door to the south facing back addition was made into a window and a new back porch/lobby was constructed to give a new back door and internal access to the original outside w.c. At the same time, a new bathroom with a bath and wash hand basin, but no w.c, was installed at first floor level in the small back addition above the kitchen. Central heating was also installed, including the installation of a radiator in the cold ground floor W.C ground floor w.c:

Despite the modernisation, the narrow downstairs W.C. compartment was left without a wash-hand basin. Although the W.C's single leaf brick wall was rendered externally, the floor was also never adequately damp-proofed, the consequent rising damp leading to the lifting and break-up of the thermo plastic floor tiles. The lid to the W.C is also missing

**Justification:** With no wash-hand basin on the ground floor and the upstairs bathroom being the furthest possible walking distance in the house , anyone using the ground floor w.c., particularly children, are likely to forego washing their hands. The inconvenient location of the W.C. and its extreme separation from the w.h.b. is also likely to have some physiological effects. The related risk of washing hands in the nearby sink is scored under food safety; the unhygienic floor to the W.C. compartment is also scored under domestic hygiene

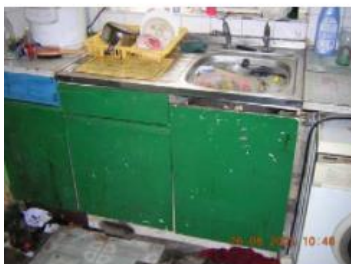
#### **Hazard 16 – Food Safety - 1930, 2 Storey, Semi-Detached House**

Work surface

The property is brick built with pitched slate roof. There is linoleum missing from several areas of the floor exposing a damp and worn concrete surface, the base units are rotted and broken and in one or two places, the doors to the base units are missing. The bottom area of glazing to the rear external door has been broken and a piece of plywood has been crudely fixed within the doorframe. The work surfaces are loose, damaged and worn, and the shelves in the cupboard units are in a similar condition. The tiles to the splash backs behind the work surface and sink are also loose, cracked, and affected by mould growth. There are one double and one single electric sockets.

**Justification:** The lack of adequate food storage facilities, which could lead to food spoilage. The food preparation surfaces (and other surfaces) are inadequate in size, and are not capable of being cleaned and kept free from bacteria. As well as the mould

growth, the splashbacks are in disrepair and cannot be kept clean. The condition of the floor also prevents ready and thorough cleansing of the floor. All these factors increase substantially the likelihood of a food related illness over the next twelve months
